THE CALIFORNIA EARTHQUAKE OF 1906

T h e
California Earthquake
of 1906

Edited by
David Starr Jordan

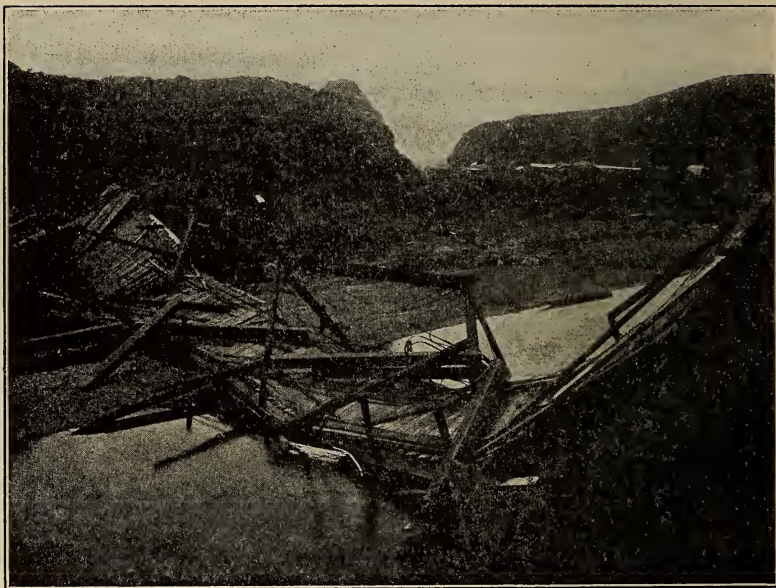
Alder Creek Bridge, Mendocino County. The Earthquake Rift Is near the Middle of the Picture.

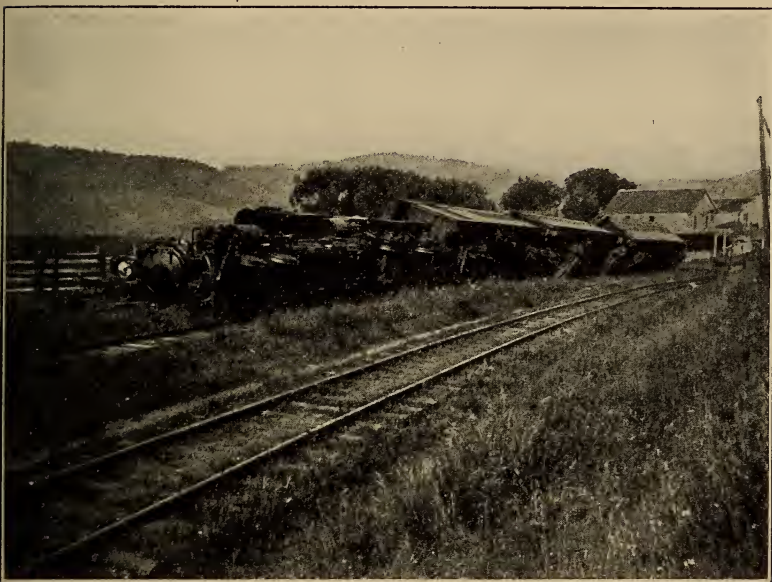
Train Overturned by Earthquake, Point Reyes Station, Marin County, Cal.

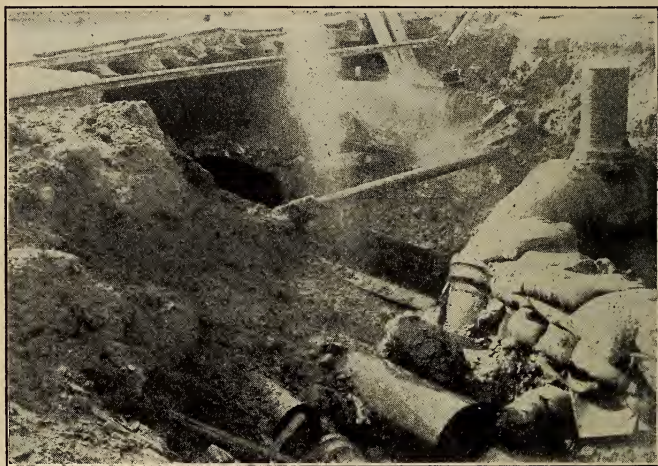
FIG. 13—Scene Corner of Howard and Seventeenth Streets Showing Rupture of Car Tracks, Sewer, Water and Gas Pipes.

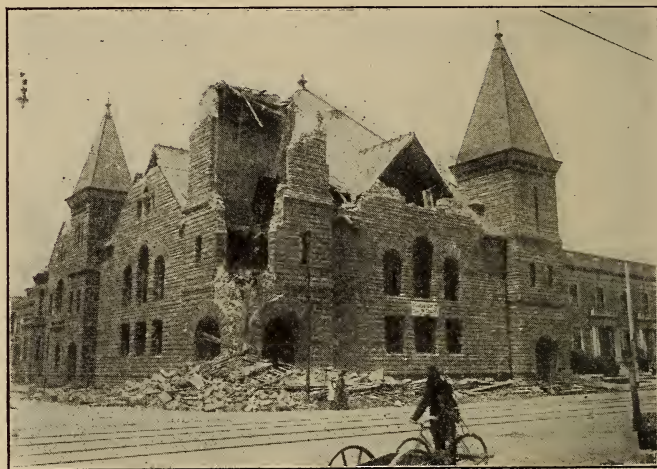
FIG. 19—First Baptist Church, Oakland, California. The Dangerous Tower Was Pulled Down Several Days after the Earthquake.

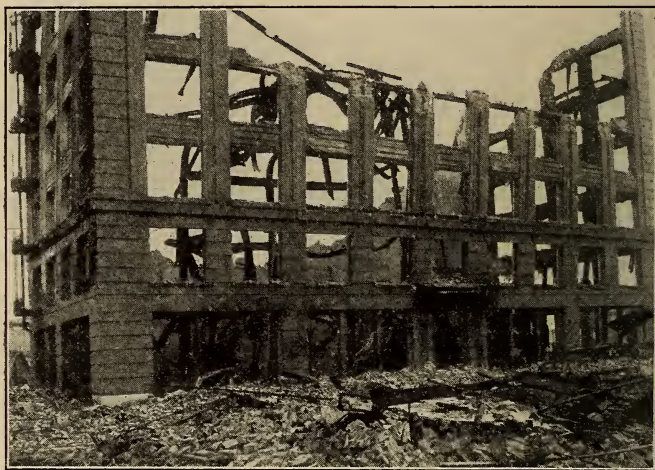
FIG. 22—*Fire Ruins of the Cowell Building, a Class B Structure, Showing the Great Destruction by Fire.*

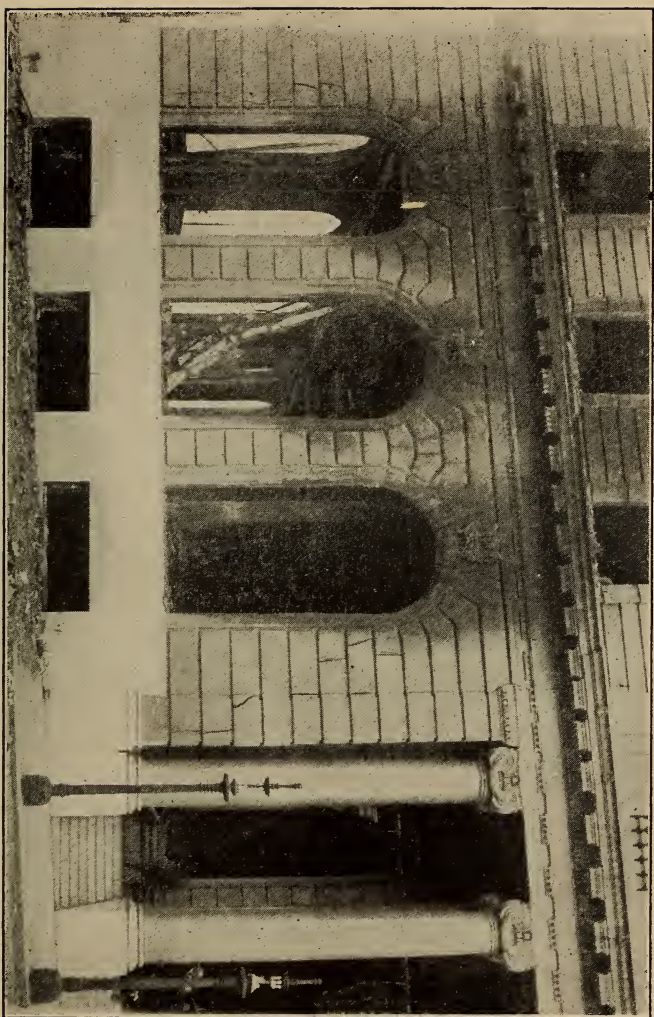
FIG. 25—St. Francis Hotel, Southeast Corner, Showing Heavy Earthquake Cracks in the First Story of the Sandstone Front.

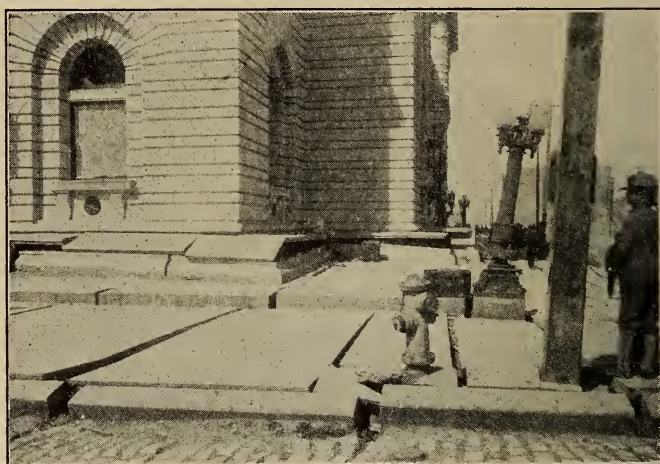
FIG. 27—General Postoffice, Southwest Corner, Showing Severe Distortion and Subsidence of the Sidewalk and Street Levels.

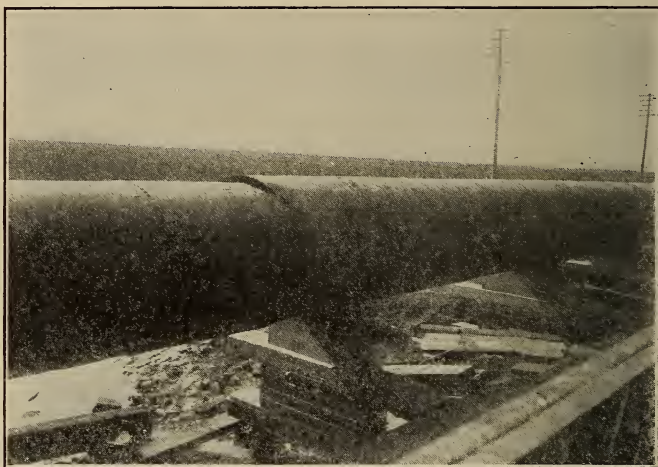
FIG. 31—Rupture of the 44-inch Crystal Springs Conduit on the San Bruno Marsh; Picture Taken May 2, 1906. The Wooden Supports under the Pipe Are Temporary Forms Built after the Catastrophe. The Pipe Has Been Straightened Preparatory to Repairing the Transverse Riveted Joints.

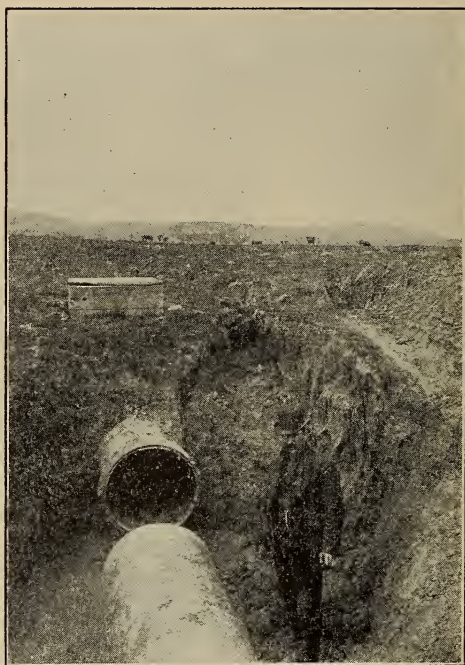
FIG. 34—Rupture on Pilarcitos Pipe Line near North End of San Andreas Reservoir.

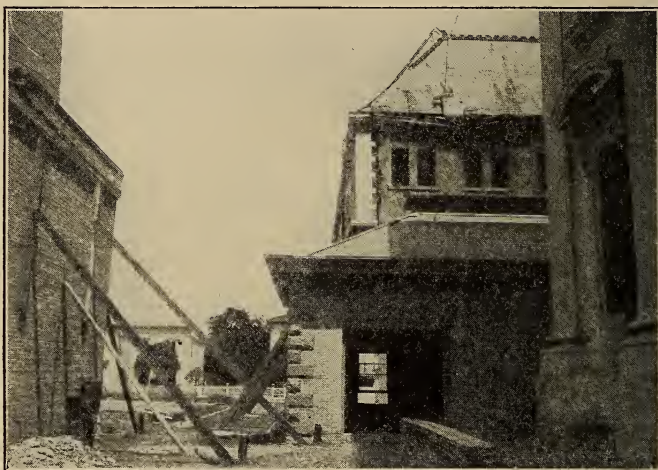
FIG. 48—Rear View, Hall of Records, San José, Showing How the Heavy Stone Outer Walls Cracked Away from the Interior Framing Due to Improper Anchoring of Walls to Floors and Roof.

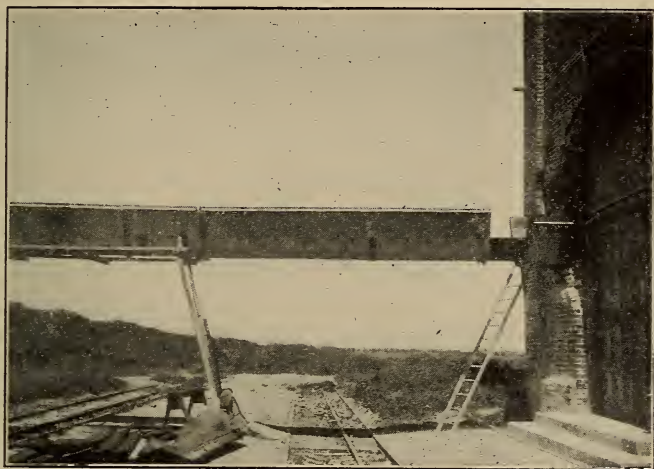
*FIG. 55—Ruptured Conveyor, the Spreckels Sugar Mill, near Salinas,
Showing Slipping of the Ground into the River.*

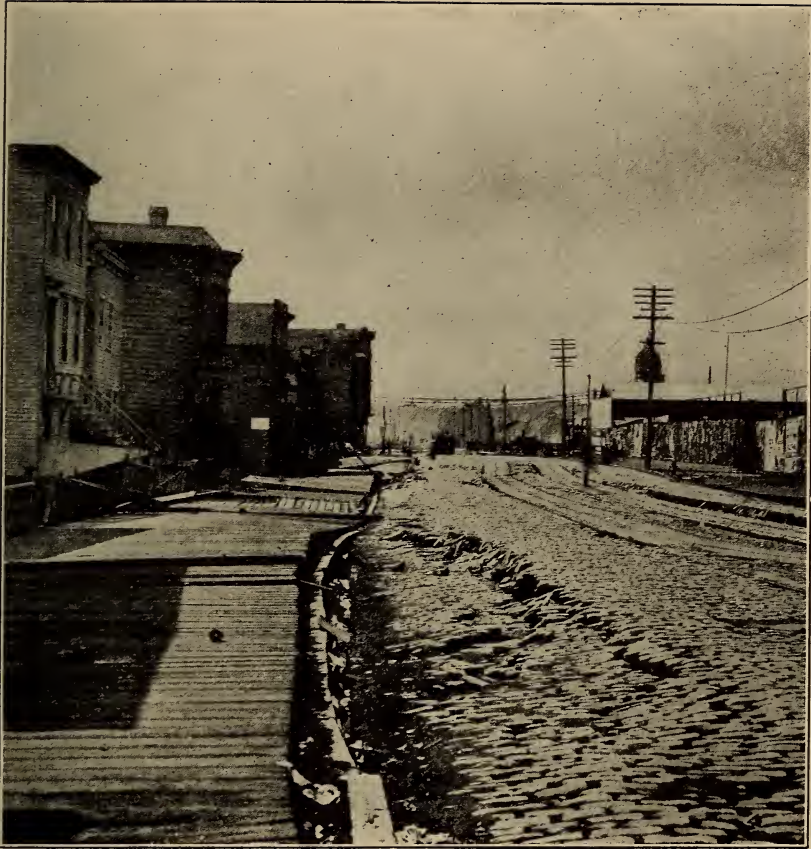
FIG. 9.—Street Scene in San Francisco, Showing Effect of the Earthquake on Filled Ground.—The Distant Part of the Street Probably Retains Its Original Level and Position. Nearer by the Ground Has Settled Several Feet and Has Also Moved to the Left.

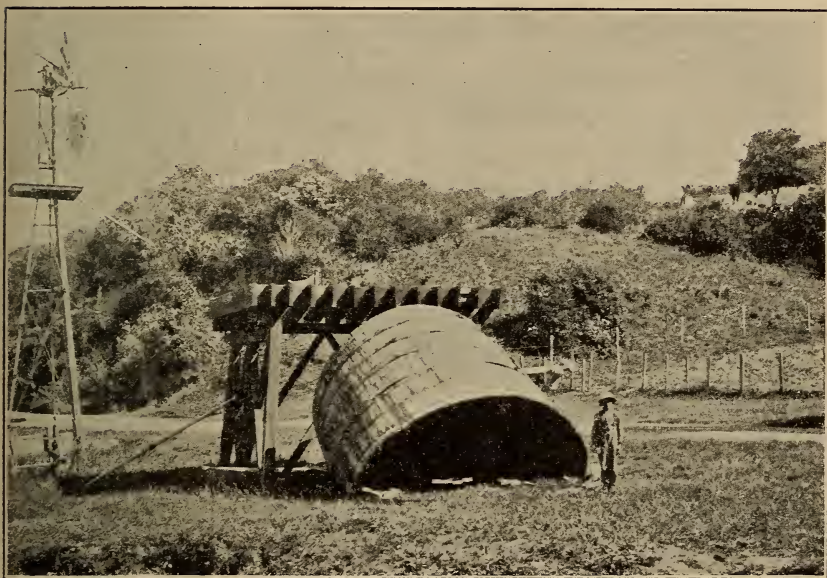
FIG. 12—*Water Tank Thrown from Its Pedestal by the Earthquake.*

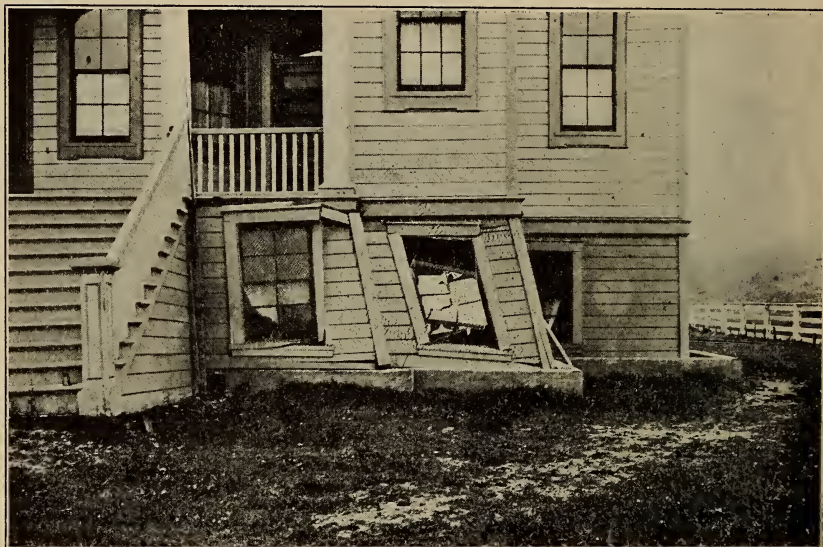
FIG. 13—School-House at Point Reyes Station, Near Inverness; Shifted Horizontally Two and One-Half Feet by the Earthquake. The Corner Here Shown Was Slipped from the Foundation and Rests Directly on the Ground.

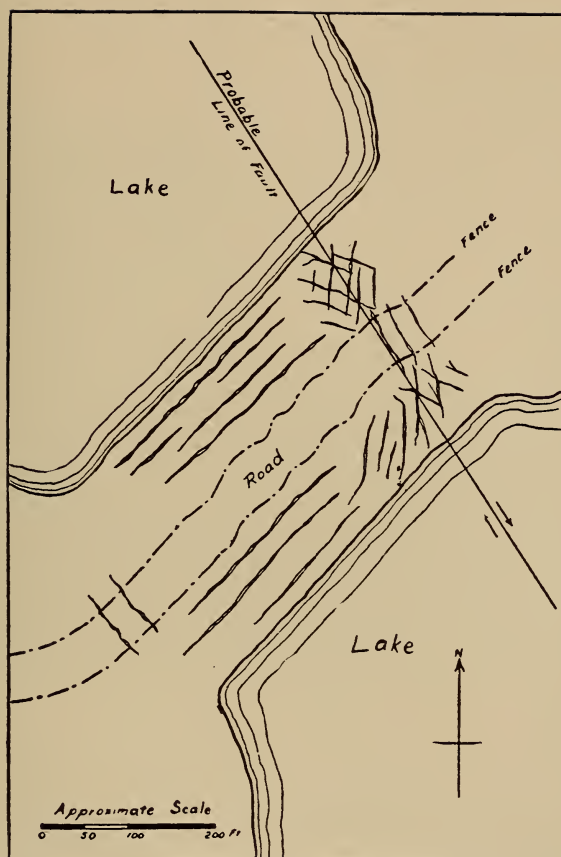
FIG. 7—Dam at Crystal Springs Lake, Showing Cracks Formed by the Displacement.

along its crest. The accompanying sketch (Fig. 7) shows the position and direction of the cracks that were formed in the dam. The larger cracks are about 6 inches wide and are parallel with the

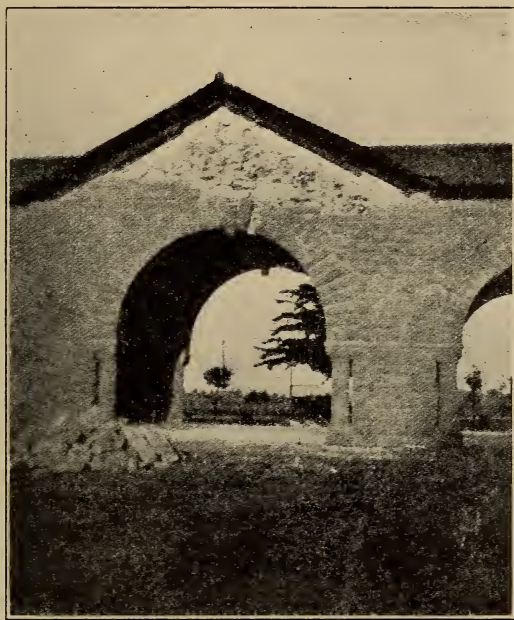
FIG. 9—*Photograph of Arches at Stanford University, Showing Keystones Lowered During the Earthquake. These Arches Were Nearly at Right Angles to the Fault-Line.*

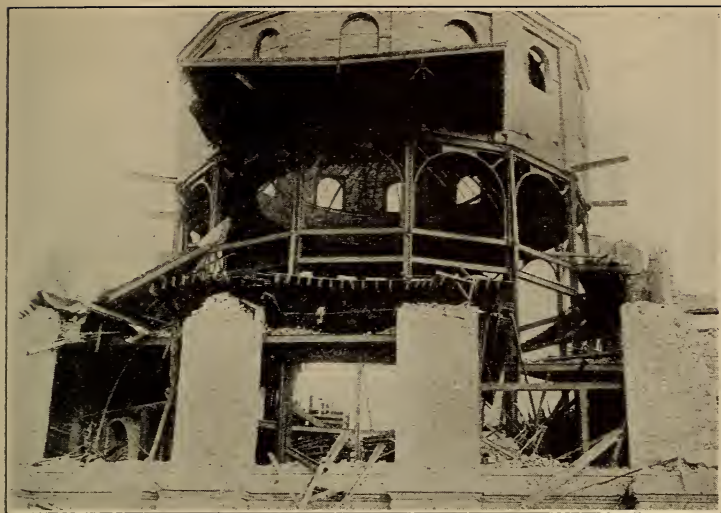
FIG. 15—The Damaged Condition of the Newly Erected Library of the Stanford University. The Central Steel Dome Behaved as an Elastic Inverted Pendulum.

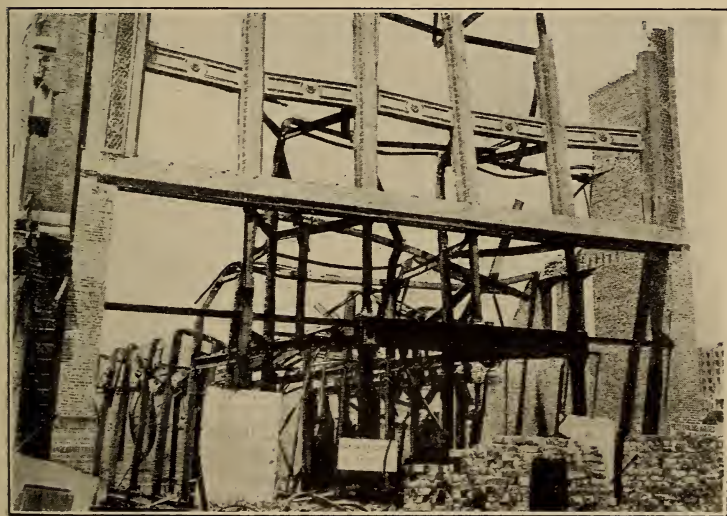
FIG. 16—The Ruined Condition of a Steel-Framed Brick House in San Francisco, Which Was Dynamited and Then Burnt, Showing the Remarkable Effects of the Intense Heat.

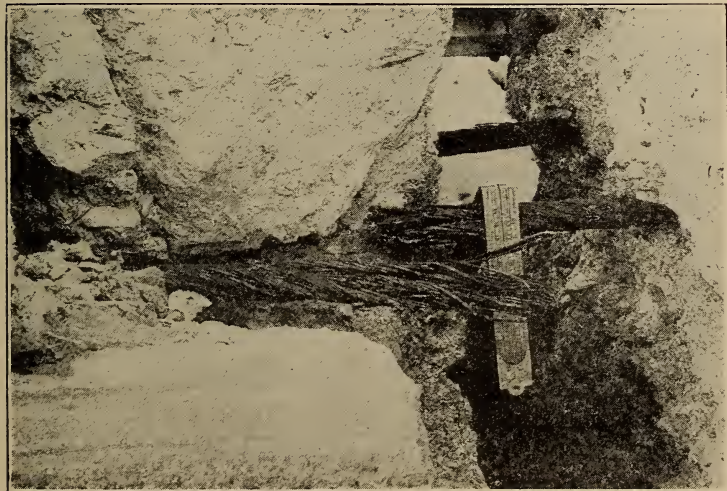
FIG. 18—*One of the Cracks of the Basement Wall. The Steel Cable, One Inch in Diameter, Which Was Embedded in the Concrete, Was Broken.*
